Manhole Inspection Summary

Manhole # S33KK_003MH

Insp Date: **12/6/06 2:25 PM**

Location Address: **1904 CHARLES ST**

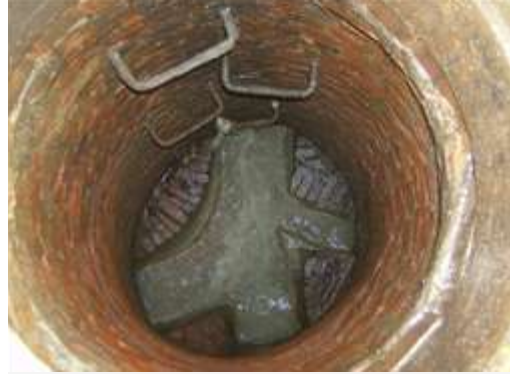
Top View

Corroded steps. Evidence of surcharge - Bench debris.

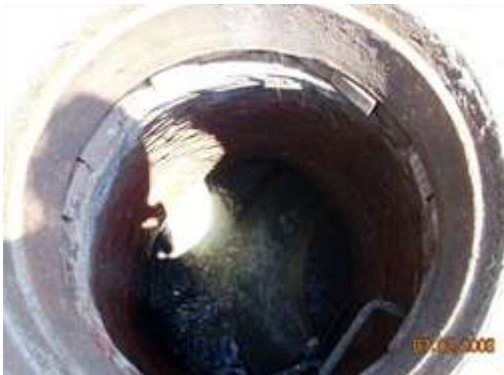
Defect

Frame leaks. Adjustment deterioration and infiltration. Corbel and Barrel infiltration - other side.

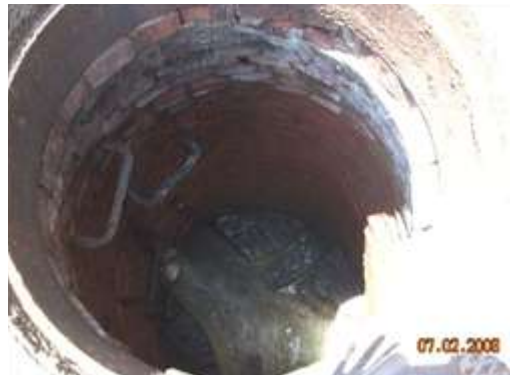
Defect

Frame leaks. Adjustment deterioration and infiltration. Corbel and Barrel infiltration.

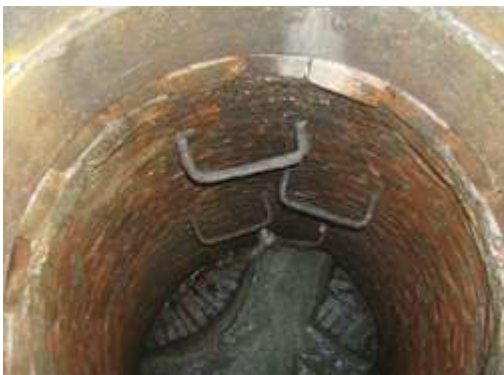
Defect

Frame leaks. Adjustment deterioration and infiltration. Barrel infiltration.

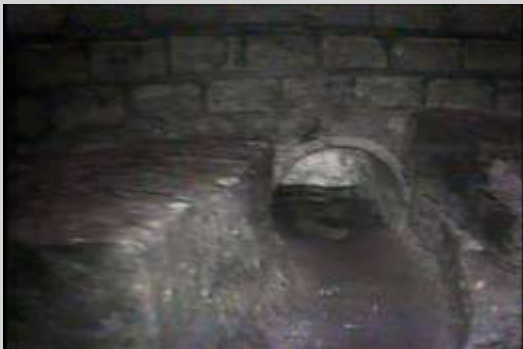
10 in. Circular Gravity Sewer Pipe In @ 3 O'Clock

Deposits: ☐ None ☐ **Mud** ☐ Sludge ☐ Debris ☒ **Grease**

Silt Depth: **0** (in.) Deposits Extent: **Light**

Infiltration: **Evidence** Pipe Seal Cond: **Cracked**

Connects To: **Stub connection / abandoned**

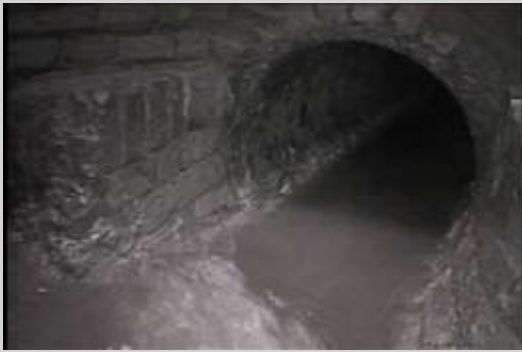
12 in. Circular Gravity Sewer

Barrel deterioration and infiltration. Channel deterioration.

Deposits: ☐ None ☒ **Mud** ☐ Sludge ☐ Debris ☒ **Grease**

Silt Depth: **8** (in.) Deposits Extent: **Heavy**

Infiltration: **Evidence** Pipe Seal Cond: **Unknown**
